PERFORMANCE REPORT

ARL L/N 50446C

Miami-Dade County Protocol TAS 114, Appendix E (1995)

DryerWallVent, DryerWallVent Frame

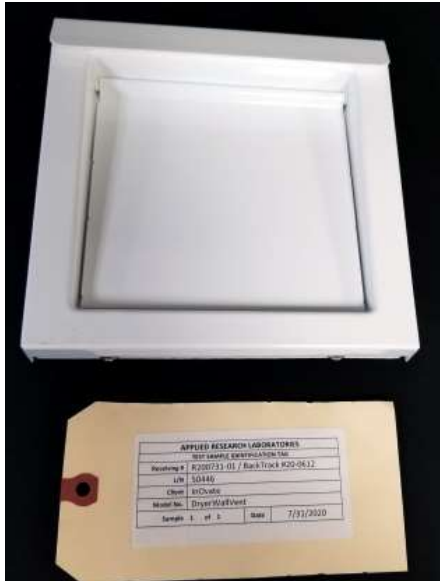
Photograph 1
DryerWallVent (Unexposed)
ARL Sample ID #20-0612

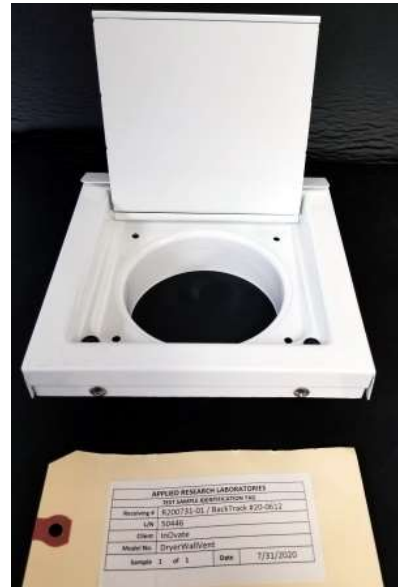
Photograph 2
DryerWallVent (Unexposed)
ARL Sample ID #20-0612

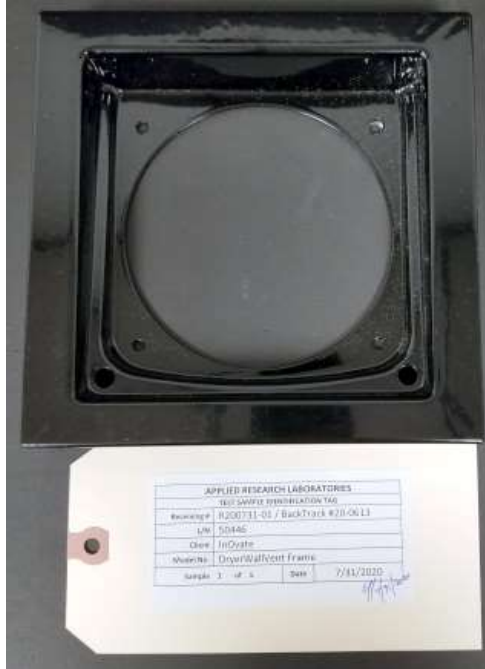
Photograph 3
DryerWallVent Frame (Unexposed)
ARL Sample ID #20-0613

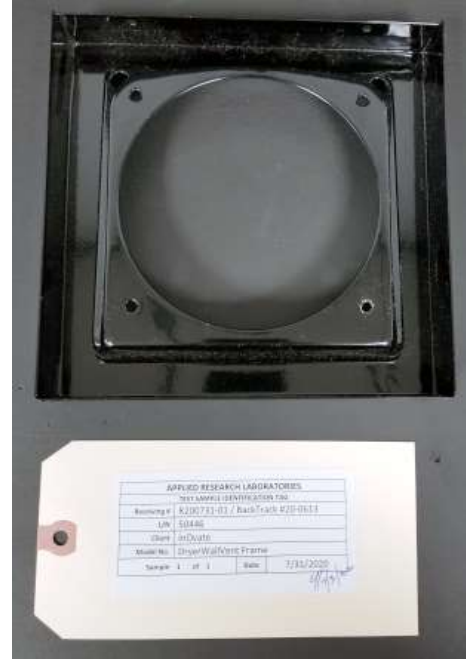
Photograph 4
DryerWallVent Frame (Unexposed)
ARL Sample ID #20-0613

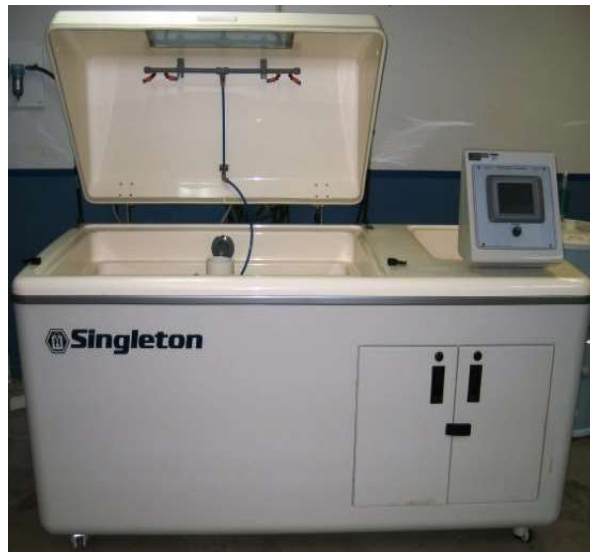
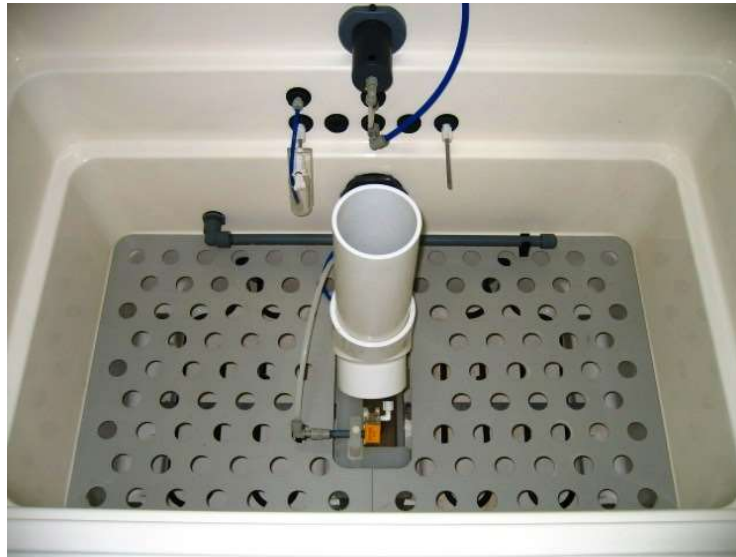
- 3.1 Cyclic Corrosion Test Chamber – The ARL Cyclic Corrosion Test Chamber was utilized to accommodate the parameters of TAS 114, Appendix E, for the purpose of testing the nails. The Chamber, Model CCT10-MB-8AD, was manufactured by Singleton Corporation. The sample space volume is 21 ft³. The inside dimensions are 48 x 33 x 24 inches. The Chamber has a temperature range of ambient - 140°F and a humidity range of ambient - 100%.

Photograph 5
Cyclic Corrosion Test Chamber

Photograph 6
Cyclic Corrosion Test Chamber

- 3.3 For the spray cycle, the temperature inside the chamber was maintained at $75 \pm 6^{\circ}\text{F}$. The fogging was achieved by using a single nozzle connected to an air supply. The solution was drawn out of the main reservoir to a secondary reservoir inside the sample space and then atomized by the nozzle and released into the chamber, thus exposing the Roofing to the salt fog.

- 3.4 During the drying cycle, the temperature inside the chamber was maintained at $95 \pm 3^{\circ}\text{F}$. The Chamber is capable of reaching the required temperature within 45 minutes as required by TAS 114, Appendix E. The drying was aided by evacuating the chamber of all sprayed solution and then beginning the heating process. The evacuation lasts approximately 5 minutes. All visible moisture was removed from the samples. Heating is accomplished by two (2) heater elements located in the bottom of the Chamber.

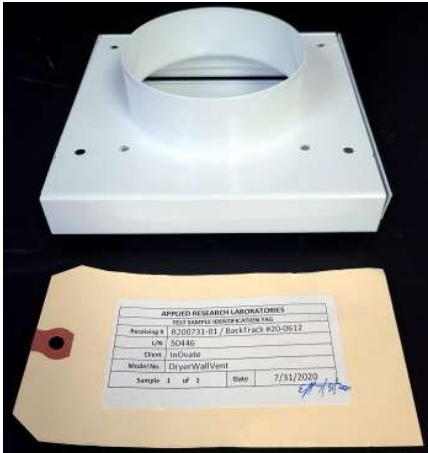
Photograph 7
DryerWallVent (Exposed)
ARL Sample ID #20-0612

Model / Sample ID #	Amount of Corrosion	Verdict ¹
DryerWallVent / 20-0612	<5%	Pass
DryerWallVent Frame / 20-0613	<5%	Pass

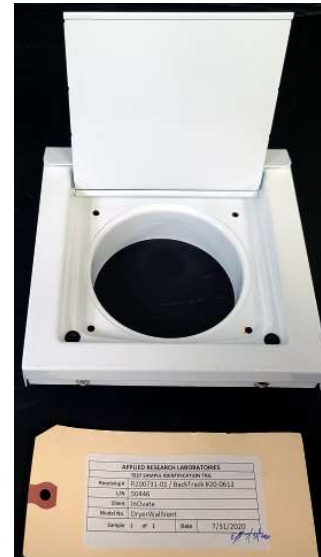
Photograph 8
DryerWallVent (Exposed)
ARL Sample ID #20-0612

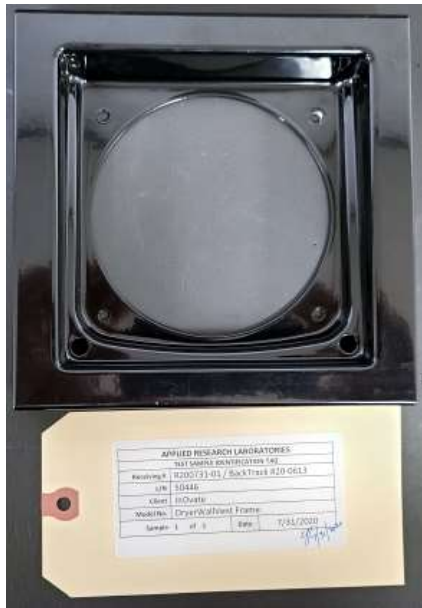
Photograph 9
DryerWallVent Frame (Exposed)
ARL Sample ID #20-0613

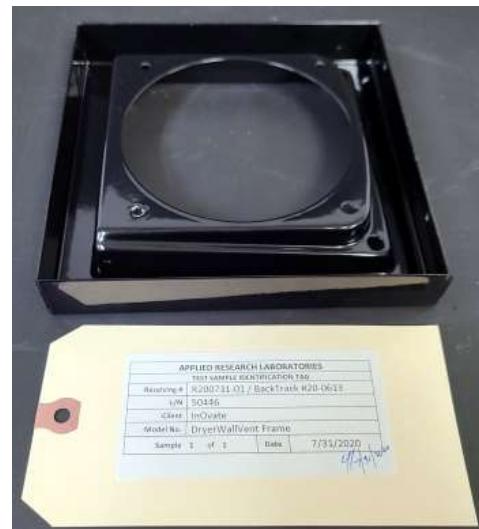
Photograph 10
DryerWallVent Frame (Exposed)
ARL Sample ID #20-0613
